National Transportation Safety Board

Safety Recommendation

Date: October 7, 1998

In reply refer to: A-98-87

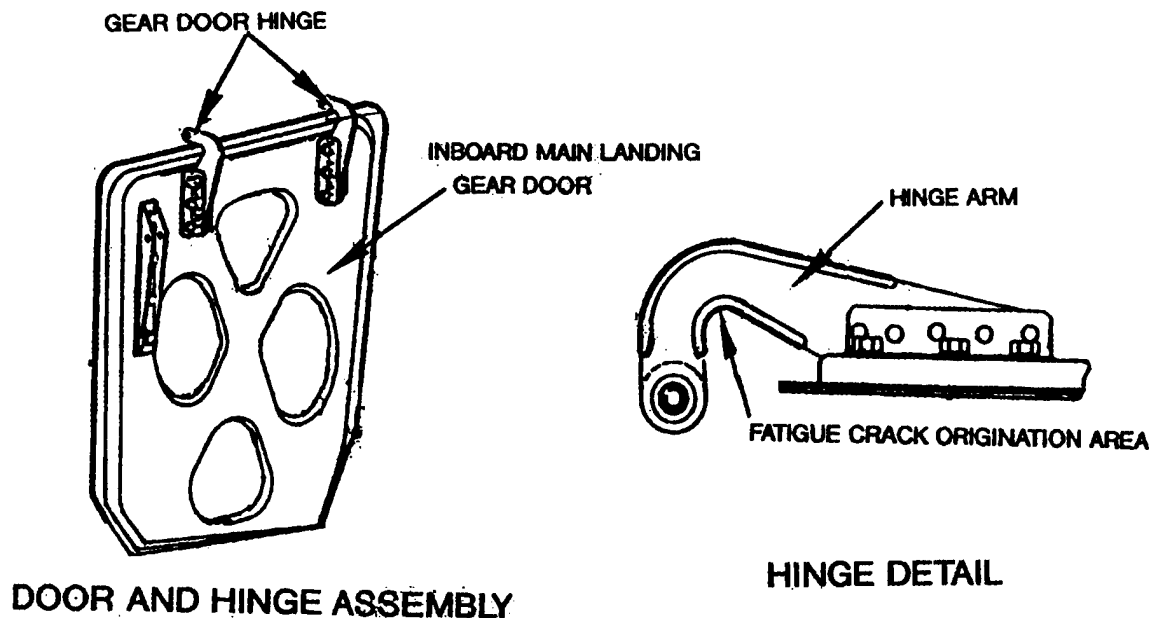
Figure 1. Piper PA-31 Main Landing Gear Door Assembly

arm (see figure 1). The arm is subjected to cyclic loading during service, and the forging flash is a high-stress region of the hinge.

In 1980, following several incidents of fatigue cracks in the original hinge, Piper Aircraft Corporation (now New Piper Aircraft, Inc.) issued Service Bulletin (SB) 682, which recommends inspection of the PA-31 MLG inboard door hinge assemblies and hinge attachment angles for cracks within the first 100 hours of operation or during the next scheduled inspection, whichever occurs first, and every 100 hours thereafter unless/until an acceptable replacement part is installed. The SB recommends that all cracked door hinges be replaced with the improved P/N 47529-32 hinge assemblies before further flight. Upon installation of the improved hinge assembly, repetitive inspection of the hinge assembly is not required. On December 19, 1980, the Federal Aviation Administration (FAA) issued Airworthiness Directive 80-26-05, mandating the actions specified in this SB.

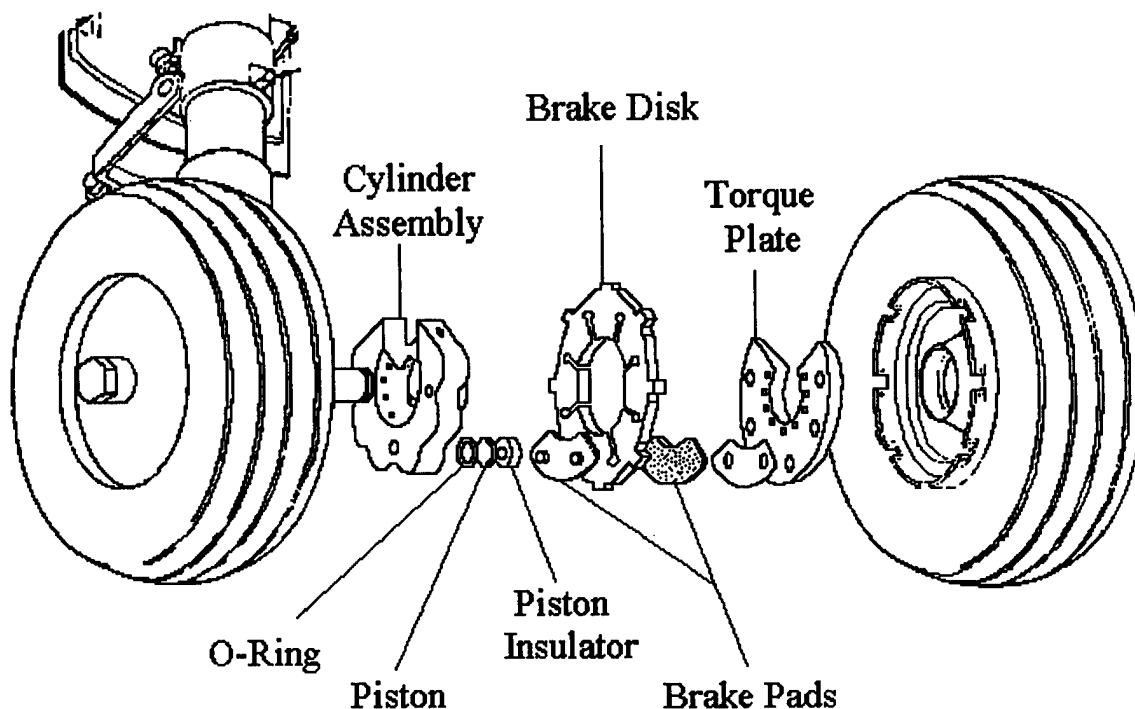
Figure 1. B.F. Goodrich 2-1203 Disk Brake Assembly

² The B.F. Goodrich P/N 2-1203 series brake assembly is a floating-type, single-disk assembly. The steel disk has smooth sides, expansion slots, and tangs around the outer diameter. The tangs are keyed into the wheel so that both rotate together. The disk floats in and out of the wheel to prevent binding during brake application. The cast-aluminum alloy housing, which is bolted to the landing gear strut, has six cylinders, aluminum alloy pistons, and O-rings to prevent leakage. Each piston is protected from the brake pad by an asbestos piston insulator to minimize heat transfer from the disk to the piston. During brake application, hydraulic fluid is forced into the cylinder, and the piston pushes against the insulator, movable brake pad, disk, and opposing brake pad and torque plate to clamp the rotating disk. The airplane involved in the Montreal accident had the original design P/N 2-1203 wheel brake assembly. Subsequent P/N 2-1203 brake assemblies have suffixes of -1 through -4.

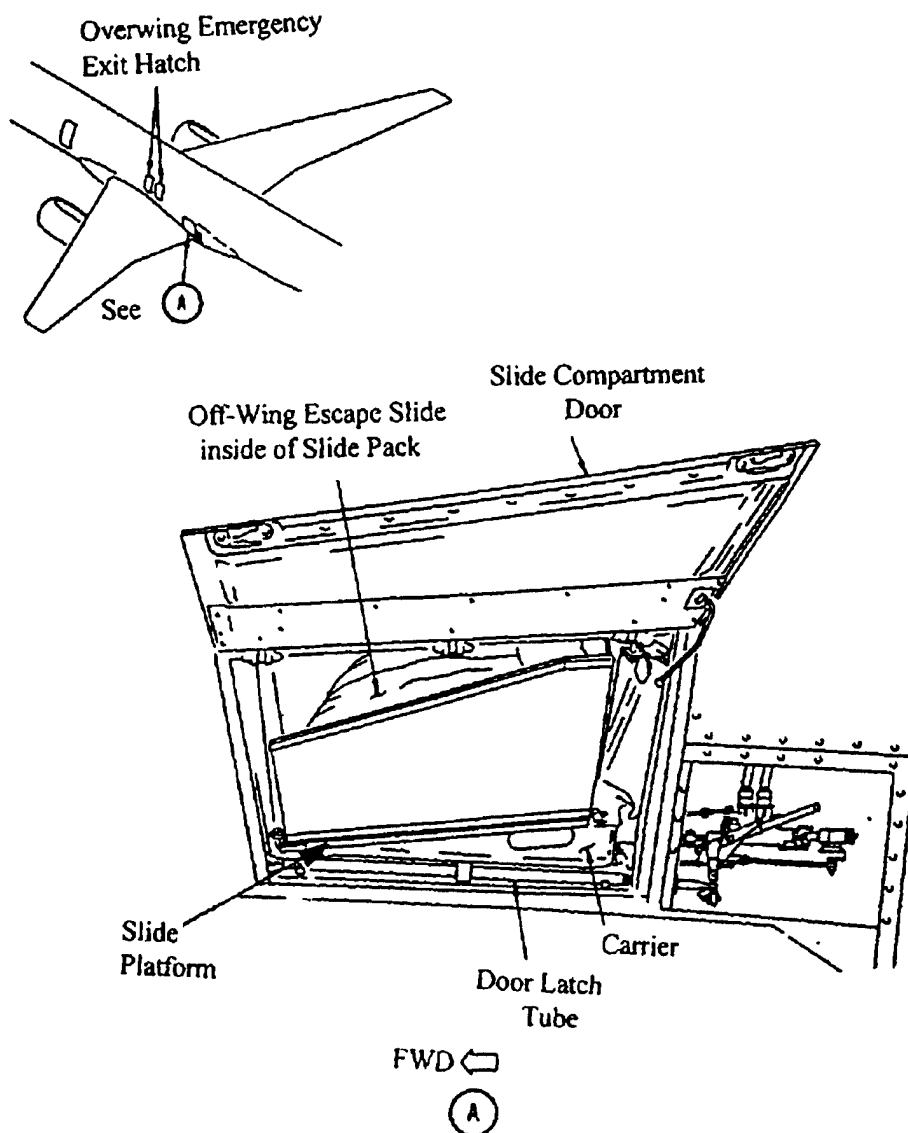
Figure 1.—B-757 Off-Wing Escape Slide Assembly

down position, stating that "it took several attempts to move the actuator handle to the latched position." The mechanics stated that after the door was latched one mechanic ran his finger around the door to ensure it was closed, and then both mechanics checked the EICAS in the cockpit to ensure that the door was closed. One of the two mechanics said that he had received instructions on how to replace the slide about 4 or 5 years ago during a 2-week B-757 initial maintenance training class that provided instructions on all B-757 systems. The other mechanic had not yet received training on the B-757 off-wing escape slide replacement during his 3 months of employment at Delta.

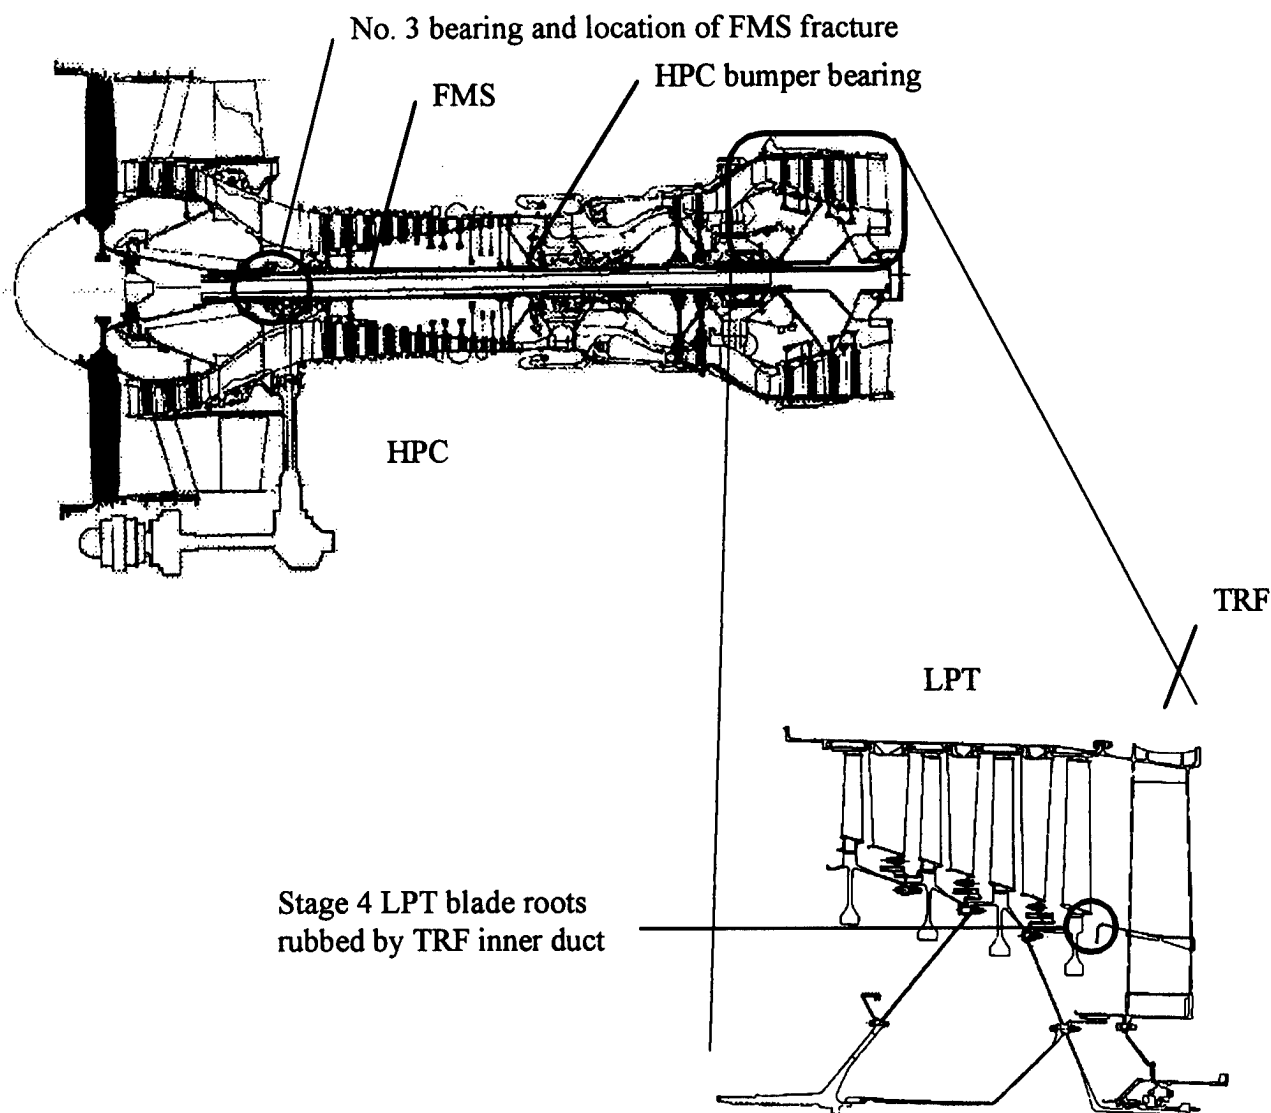
Figure 1. Cross section of CF6-50 engine and expanded view of LPT module

Disassembly of the engine, serial number (SN) 455-954, at GE's Engine Maintenance Center, Ontario, California, under the direction of the National Transportation Safety Board, revealed that the fan midshaft (FMS) was fractured circumferentially, just aft of the No. 3 (roller) bearing. Although the No. 3 bearing was damaged, the damage was typical of secondary damage that would have occurred late in the engine failure sequence.

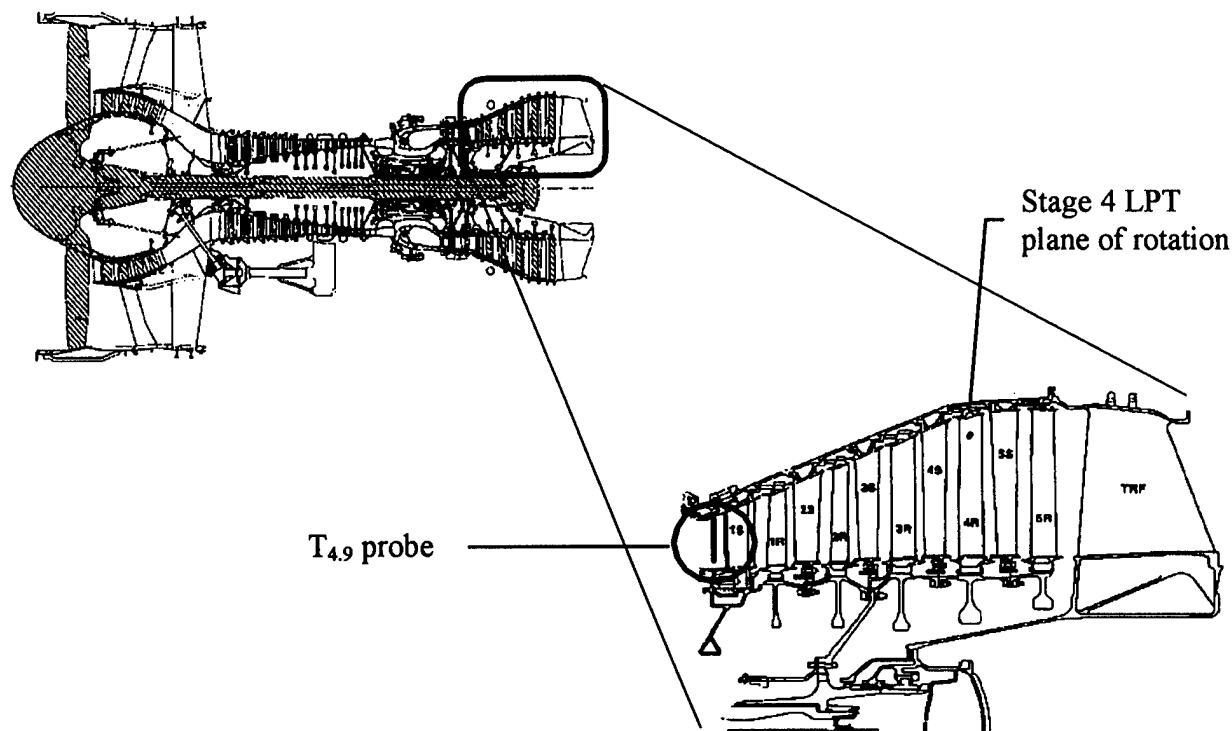
Figure 2. Cross section of CF6-80C2 engine and expanded view of LPT module

The Safety Board is aware of a similar event that occurred on September 5, 1997, when a Federal Express (FedEx) McDonnell Douglas MD-11 airplane, equipped with GE CF6-80C2 engines, had an uncontained LPT failure in the plane of the stage 4 LPT rotor. The disassembly of the FedEx engine showed that a stage 1 LPT airseal segment had broken loose from the LPT case and passed through the gaspath causing the breakage of the downstream turbine blades. As in the American Airlines LPT, the damage in the FedEx LPT rotor was more extensive downstream along the gaspath. The evidence shows that both the American Airlines and FedEx LPT cases withstood the initial containment challenge of the separation of an LPT blade; however, neither case could withstand the loads imparted by the resultant mass of broken LPT airfoils. This suggests that the design containment capability of the LPT case is inadequate.

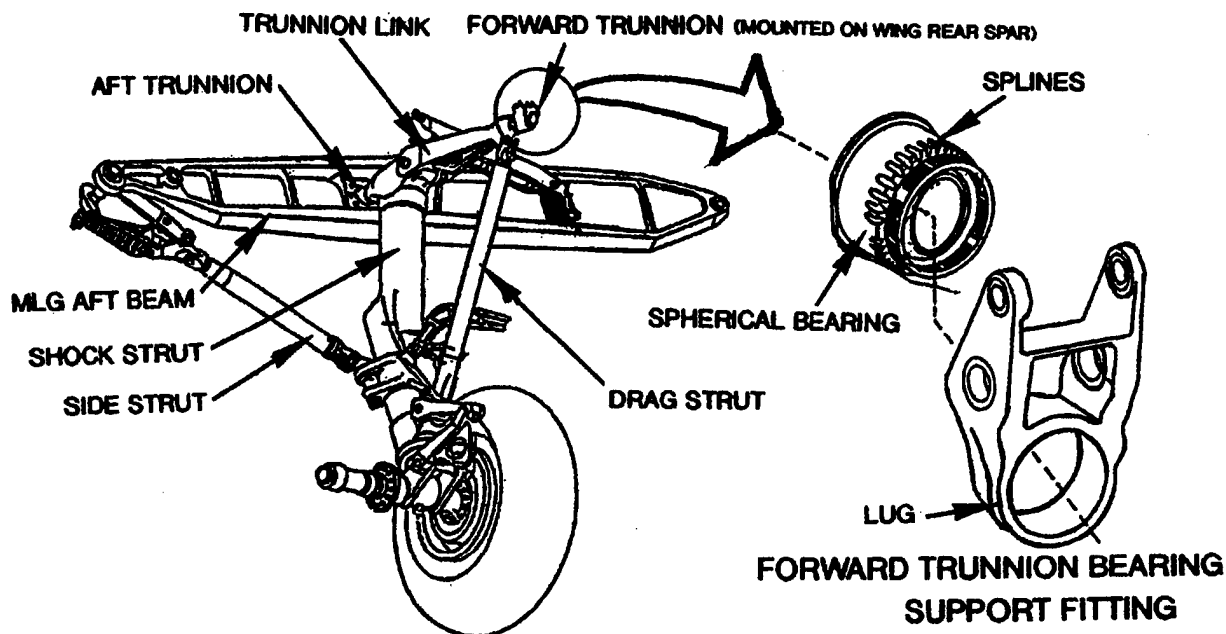
Figure 1. Boeing 727 Main Landing Gear Assembly

The right MLG of the B-727 is a conventional, two-wheel landing gear with three support points: the forward trunnion, the aft trunnion, and the side strut (see figure 1). A trunnion link is mounted between the shock strut and the rear spar. The aft end of the trunnion link is pinned to the shock strut, and the forward end pivots in a spherical bearing mounted in the forward trunnion bearing support fitting.¹ The spherical bearing has external splines that are used for locking the bearing assembly and retaining it within the support fitting lug. The splines contact a portion of the inner surface of the lug, leaving the gaps between the splines exposed to possible corrosion. The trunnion bearing support fitting is a round housing made from 4330M steel. The inner bore of the housing has chrome electroplating, which is the bore's primary means for corrosion protection. The fitting is mounted on the rear spar of the wing with high-strength bolts.

Examination of the trunnion bearing support fitting at the Safety Board's materials laboratory revealed corrosion at the forward edge of the fitting's lug in many of the exposed areas between the bearing splines. Fatigue cracking emanated from two locations within a severely corroded area, and intergranular stress corrosion cracking (SCC) stemmed from the fatigue cracking. This corroded area was 0.15-inch wide by 0.37-inch long by 0.07-inch deep. The fracture was caused by a combination of fatigue cracking and SCC.

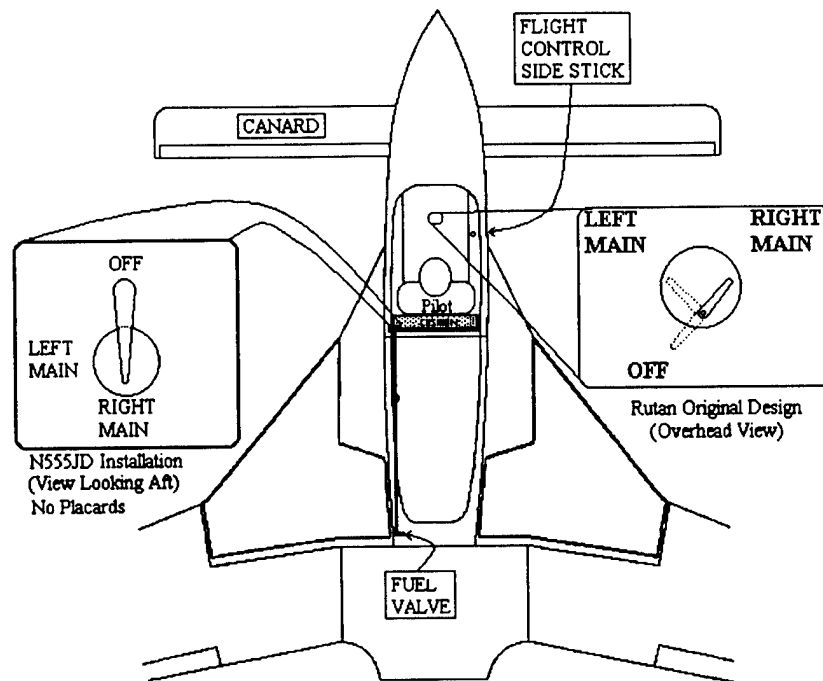
Figure 1—Comparison of fuel selector handle locations in Long-EZ

N555JD vs. Original design

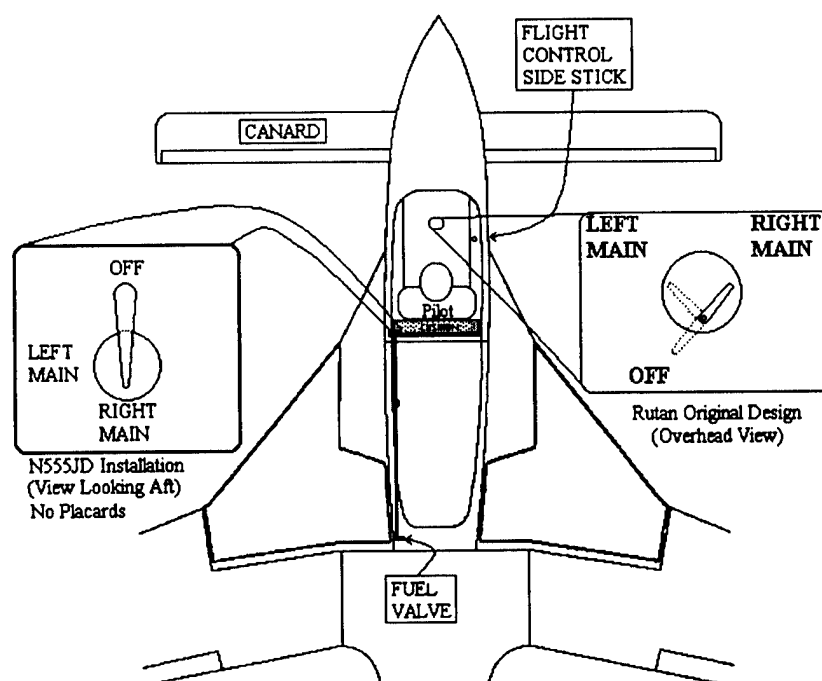
Figure 1—Comparison of fuel selector handle locations in Long-EZ

N555JD vs. Original design

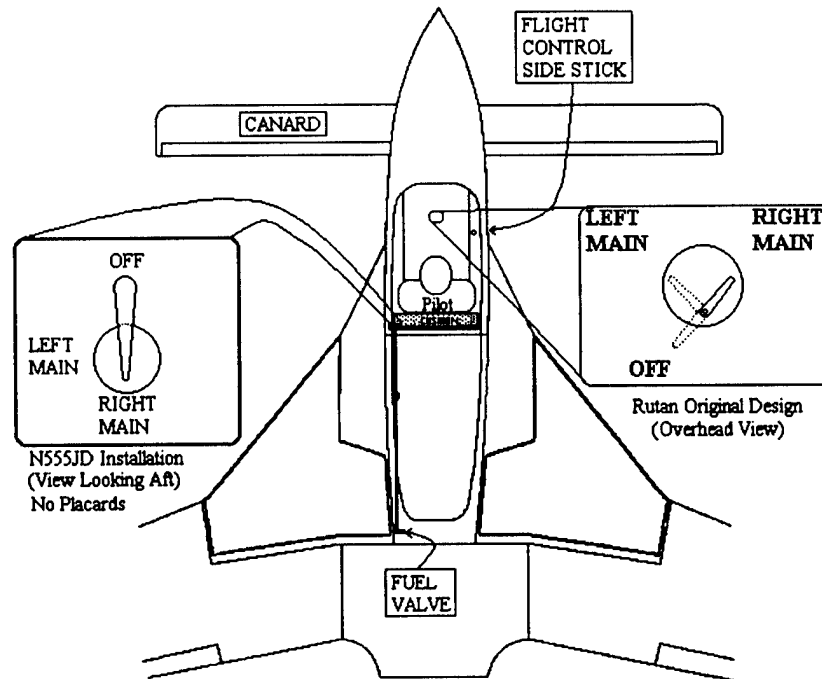
Figure 1—Comparison of fuel selector handle locations in Long-EZ

N555JD vs. Original design

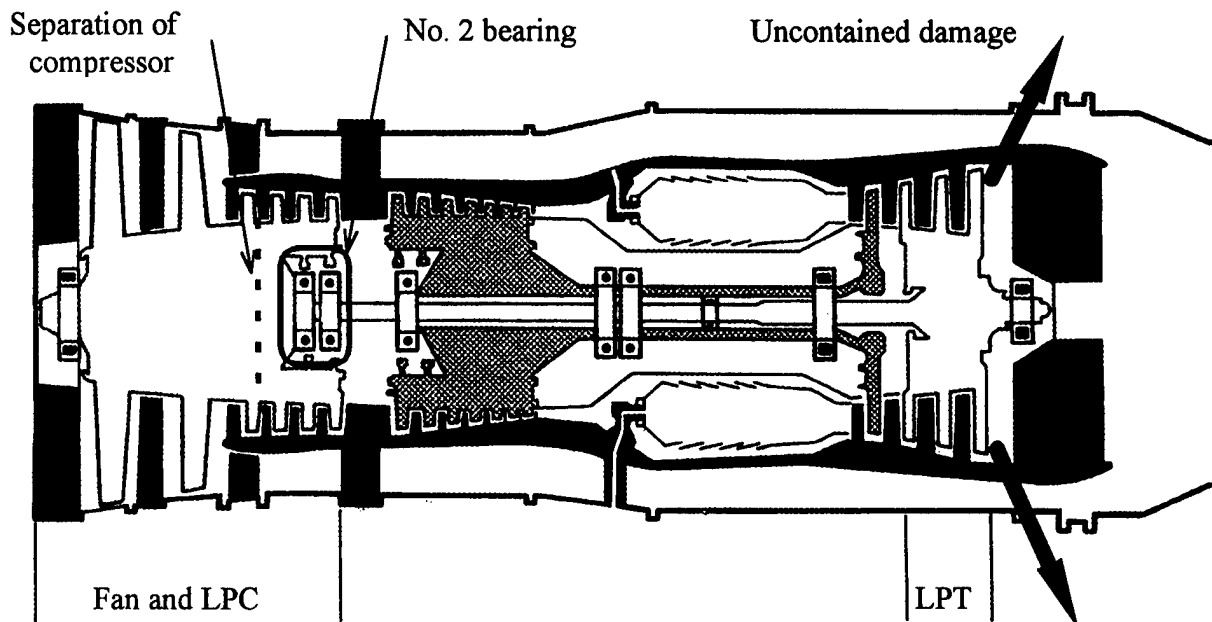
Figure 1. JT8D engine

The JT8D engine's low pressure rotor system is made up of a two-stage fan, which consists of the 1st and 2nd stage fan rotors,³ and a four-stage low pressure compressor (LPC), which consists of the 3rd, 4th, 5th, and 6th stage compressor rotors. The two-stage fan and four-stage compressor are joined to the three-stage LPT, which consists of the 2nd, 3rd, and 4th stage turbine rotors, by a drive shaft, all of which rotate as one unit under normal conditions (see figure 1). The examination of the incident engine revealed that the 1st and 2nd stage fan rotors and the 3rd stage compressor rotor rotated together but independently from the remainder of the low pressure rotor system from the 4th stage compressor rotor rearward. The examination also showed that the 2nd, 3rd, and 4th stage LPT disks were intact but that all of the LPT blades were fractured adjacent to the blade root platforms, and most of the LPT vanes were missing. Although the engine was outfitted with an LPT containment shield, as required by Airworthiness Directive (AD) 94-20-09, the containment shield was broken into three pieces, and the engine was cut in two just aft of the LPT by liberated LPT blades.⁴

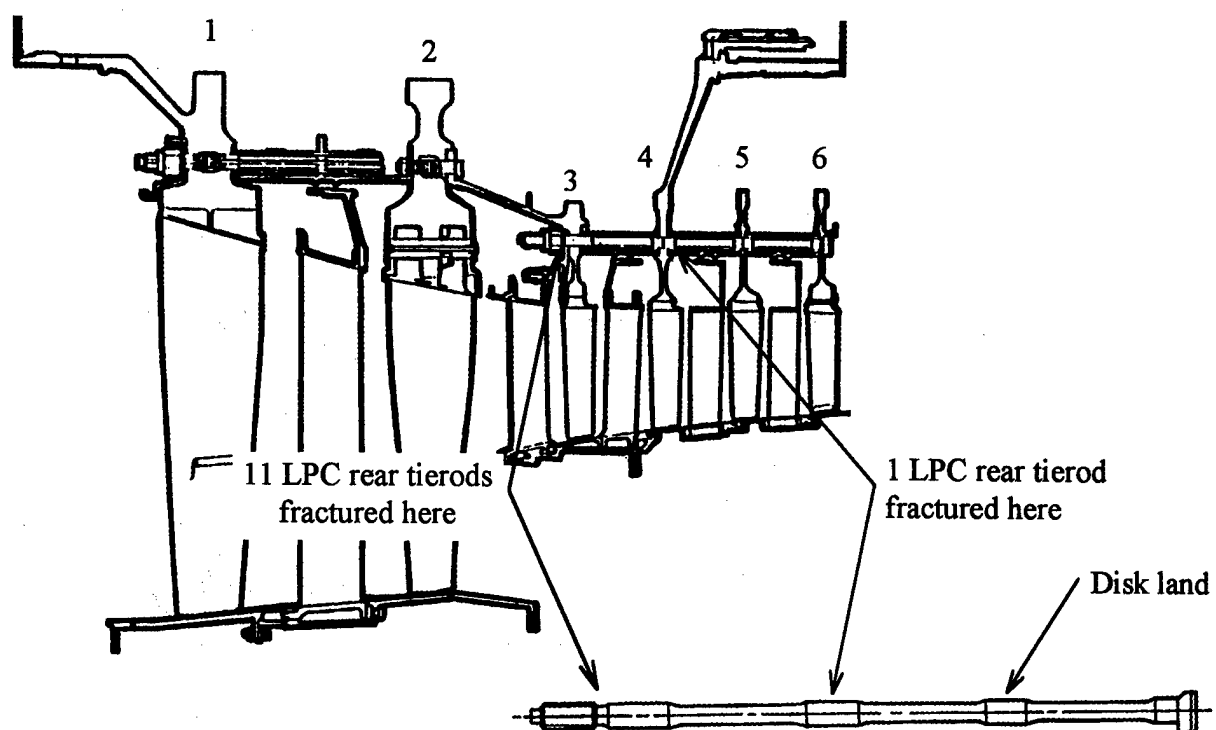
Figure 2. Cross-section of the JT8D fan and LPC and view of an LPC rear tierod

The 4 stages of the JT8D engine's LPC are held together by 12 long bolts, called LPC rear tierods, that pass through alternating disks and spacers (see figure 2). The disassembly of the Royal Airlines LPC revealed that one LPC rear tierod, part number (PN) 789550, was fractured transversely across the tierod's 4th stage compressor disk land.⁵ The entire fracture face on the

tierod had surface corrosion, suggesting that the tierod had been broken for some time. Because of overstress, the 11 remaining LPC rear tierods were fractured at their forward ends between the 3rd stage compressor disk lands and the tierod nut threads. All six of the recovered tierod nuts and ends had numerous pockmarks on one side, and the tierod ends were bent away from the pockmarks. The pockmarks and bending damage suggest that after the initial tierod fractured and was liberated from the compressor, it tumbled around in the cavity at the front of the LPC and impacted the other tierod nuts and ends until they eventually fractured, causing the compressor to separate between the 3rd and 4th stage rotors and the engine to fail. Eleven equally spaced fan exit vanes had the imprints of the tierod nuts on the leading edge, indicating that the 11 remaining tierods fractured simultaneously when the engine failed.

The Safety Board's examination of the LPC rear tierod with the corroded fracture face revealed that a fatigue fracture originated from a small area of galling⁶ on the 4th stage compressor disk land. On July 7, 1982, as a result of 33 LPC rear tierod fractures at the 3rd and 4th stage disk land locations that caused damage in JT8D engines, P&W issued Service Bulletin (SB) 5407.⁷
